## Comparative methods to assess renovation impact on indoor hygrothermal quality in a historical art gallery

## Methods to assess renovation impact on indoor hygrothermal quality in a historical art gallery

Shashwat Ganguly <sup>a</sup>, Fan Wang <sup>a\*</sup>, Zhen Chen <sup>b</sup>, Michael Browne<sup>c</sup>

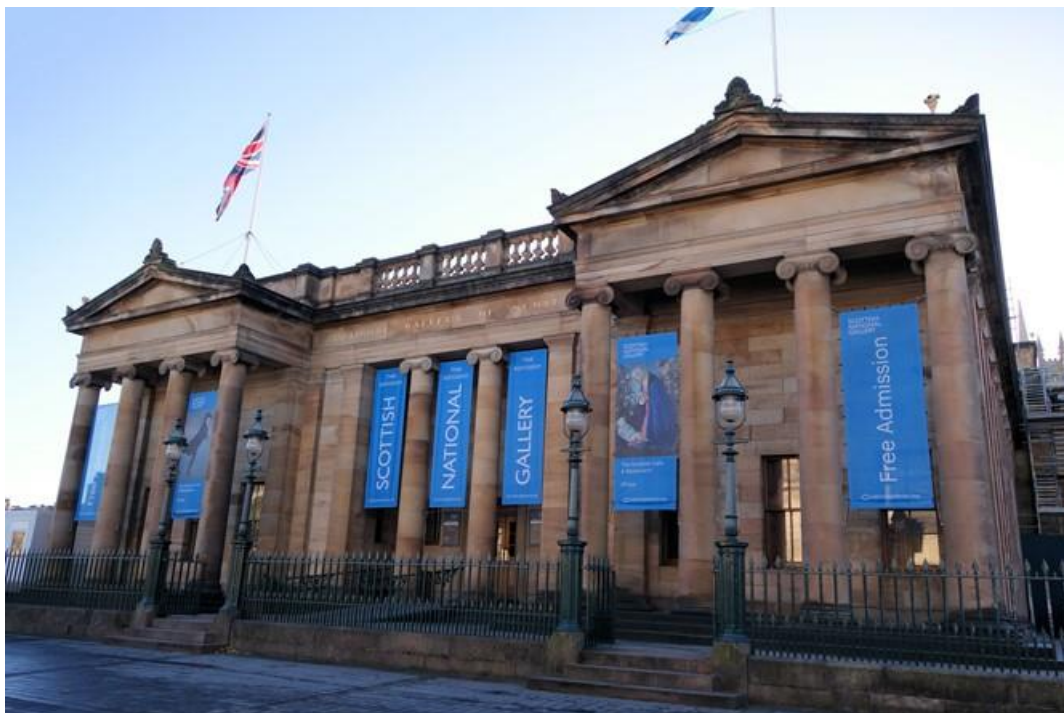
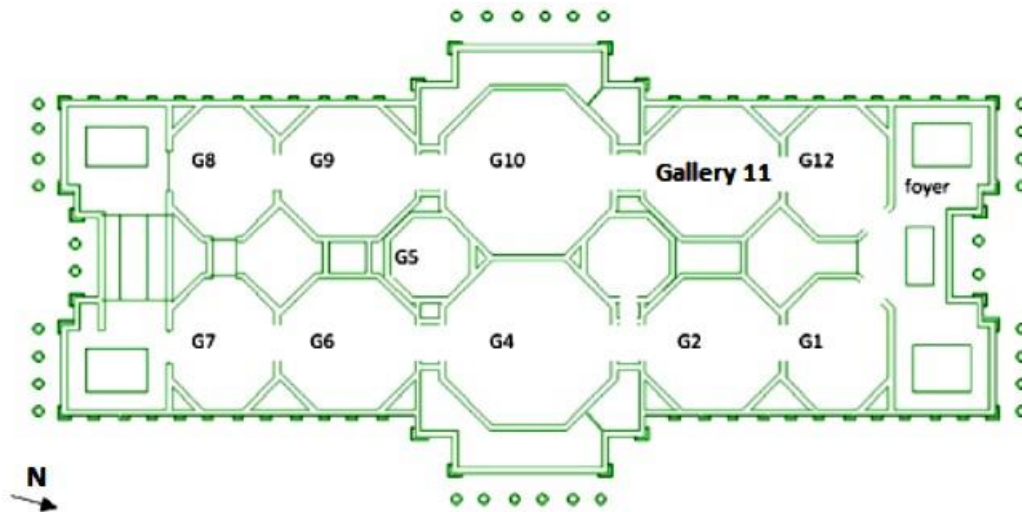
*Figure 1: NGS – Outside view (left), NGS Floor Plan with Gallery 11 highlighted (right)*

Figure 1 – The art gallery in a historical building considered for the study (top), Floor plan of the art gallery (bottom)

The building is stone-built with thick exterior walls of over one metre in width. The walls also are without fenestration and all the natural light in the building comes from the skylights installed at the curved roof cupolas [21]. The extensive use of sandstones for the external wall along with the brick-walled internal partitions significantly contributes towards the high thermal mass of the building. The paintings are mostly of the type ‘oil on canvas’ or ‘oil on panel’. Apart from the paintings, collections also comprised of work on paper, photographs, sculptures made of wood, plaster and metal.

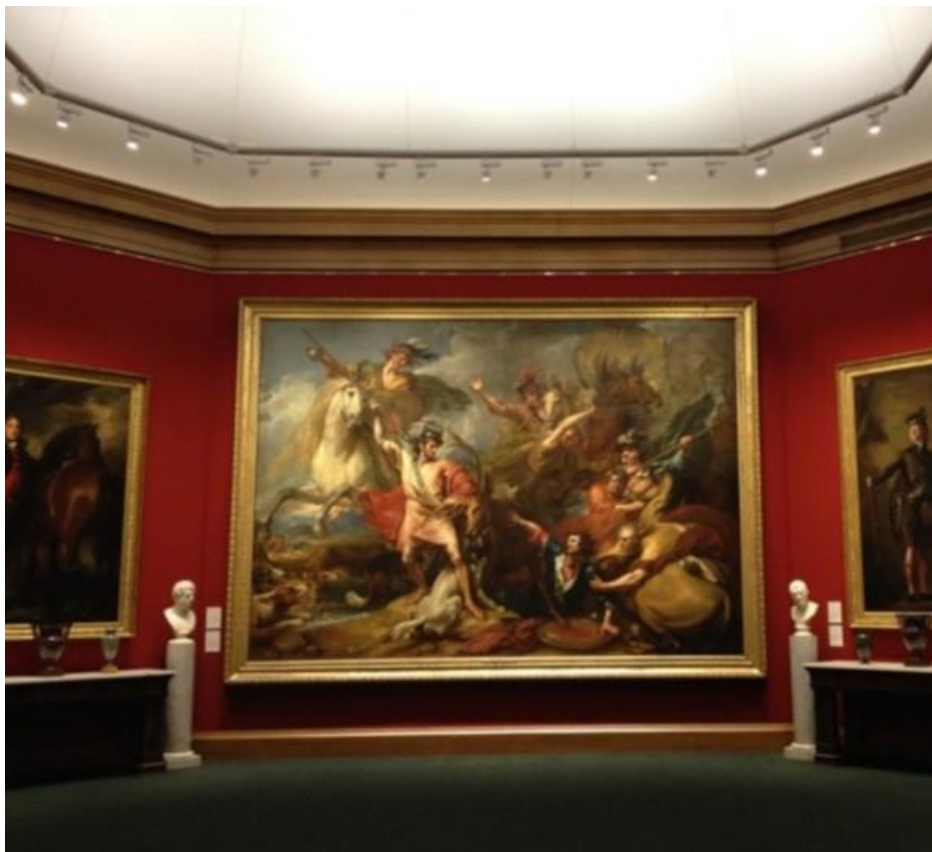
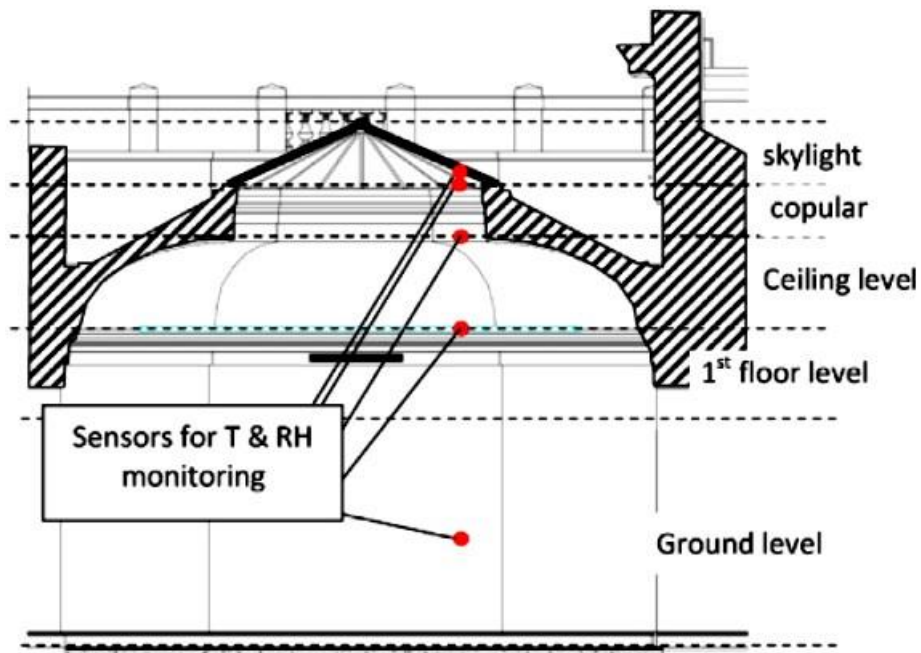
*Figure 2: NGS Gallery 11 interior (left), Cross Section of Gallery 11 (right)*

Figure 2 - Gallery 11 interior with colossal paintings (top), Gallery 11 cross-section with sensors for T/RH monitoring (bottom)

To understand the microclimatic behaviour and study the effects of the refurbishment regime, an extensive indoor environmental monitoring was conducted inside the NGS. The monitoring system was installed in one particular room – Gallery 11 (Figure 2), owing to the ease of access for installations, management permission, archive data availability and the fact that it represents most of the other gallery rooms, in terms of shape and function. Moreover, Gallery 11 is served by AHU – 1, which was reviewed to be the unit with the maximum associated indoor environmental problems. Gallery 11 is also an important recipient of the refurbishment activity, with the upgradation of skylight and the balancing of AHU1.

The data sources consisted of a combination of BMS sensors and additional installed sensors. Targeting the two critical hygrothermal parameters for artwork conservation, the BMS sensors considered for the study pertained to Gallery 11 room dry-bulb Temperature (°C) and room Relative Humidity (%RH), recorded at every 15 minute intervals. These records are stored at the BMS central server and are available upon request from the management team. Additional sensors (Table 3) were installed at different heights in Gallery 11 to observe the room T/RH in different locations. The various heights, as shown in Figure 2, chosen for installation are – visitor level (1.5m), 1<sup>st</sup> Floor level (6.5m), Ceiling level (8.5m) and Skylight surface level (9m). As the space was an operational gallery, only limited sensors were eligible for installation owing to building management restrictions.

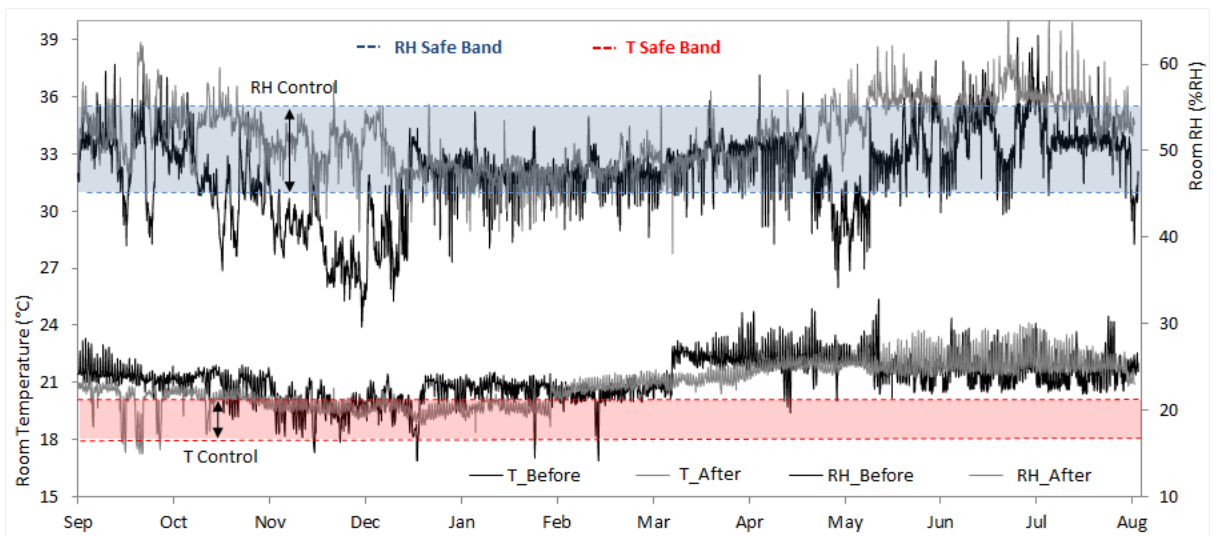
*Figure 3 - Comparison of Annual Indoor Environmental Control Quality (Before and After Refurbishment)*

Figure 3 - Comparison of Annual Indoor Environmental Control Quality (Before and After Refurbishment)

As for the indoor hygrothermal performance, it can be seen that the parameters existed more within the tight BS5454 specifications after renovation (Figure 3). Before, the gallery space remained dangerously dry (less than 30% RH) for durations of as long as over a month. A positive RII owing to the improved PIs, after renovation, for both T and RH further highlighted the renovation success (Table 5).

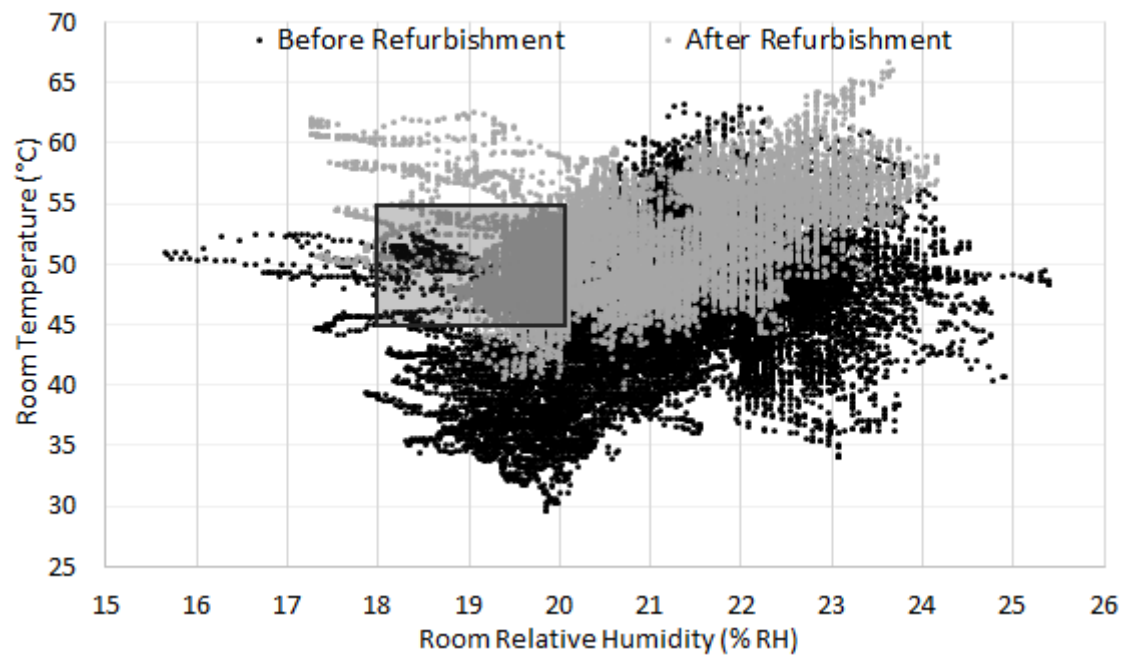
*Figure 4 – Annual comparison of Global PI for T against RH, before and after the refurbishment (with Fixed Band Window)*

Figure 4 – Annual comparison of Global PI for T against RH, before and after the refurbishment (with Fixed Band Window)

To analyse the effects of renovation on both T and RH combined, Global PI concept [7,18] was implemented in which T was plotted against RH for an annual period and compared for the period before and after refurbishment (Figure 4). On checking the hygrothermal performance through the 'tight' window representing the BS5454 T and RH specifications, it was clear that the indoor environment continued to remain hot and dry beyond the specifications with 11% cases, which existed in the 'fixed' window, improved to about 27% after refurbishment (Table 6). This results from overheating of the cold outdoor air which enters the room and becomes dry, demanding adequate humidification. The hygrothermal performance is much better if looked through the 'relaxed' window, with 97% cases existing within the 'relaxed' T and RH specifications. RII demonstrates that the improvement is more pronounced in the case of the fixed window. This improvement is a direct result of the improved supply air flow rate achieved by increased fan speed and balancing the AHUs with reconfigured supply ducts from AHU to the various rooms. As the air flow rate in Gallery 11 is now desirably higher than it was before, the supply T and RH efficiently offsets the changes incurred by the variations brought by occupants and external

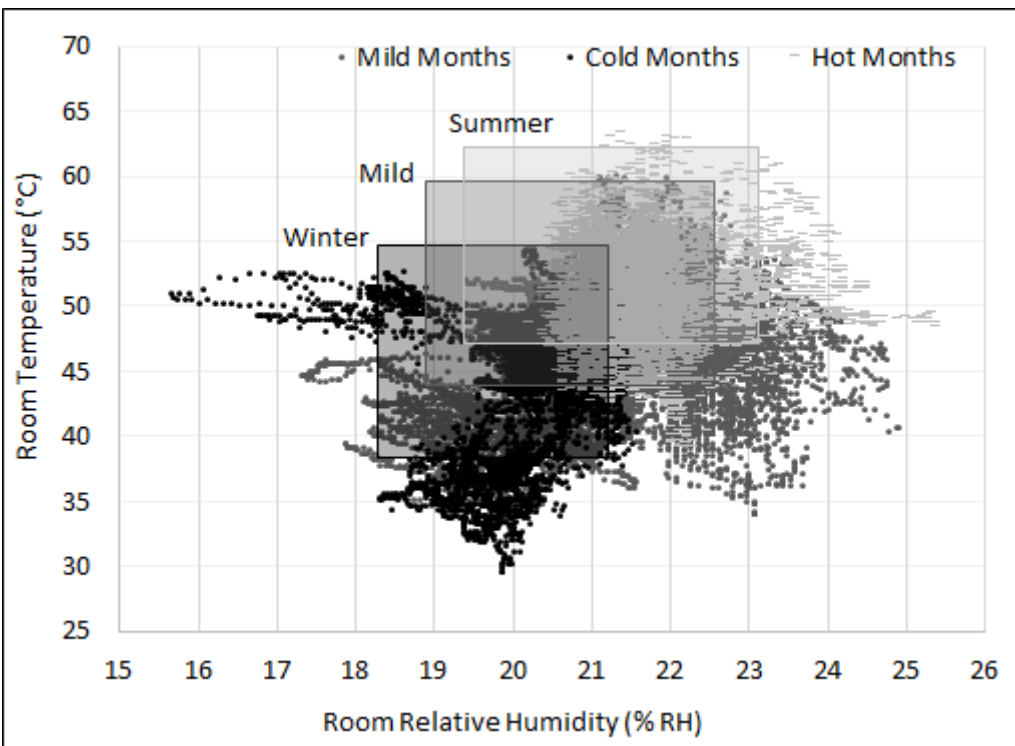
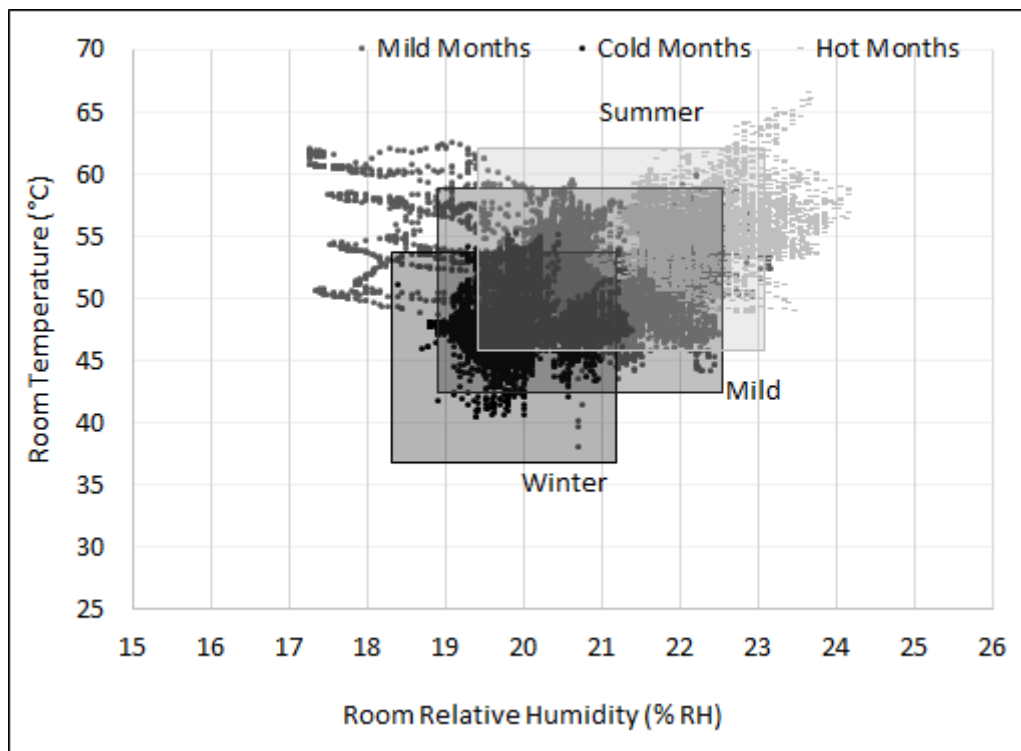
*Figure 5 – Seasonal comparison of Global PI for T against RH, before (Top) and after (Bottom) refurbishment (with Adaptable Seasonal Windows)*

Figure 5 – Seasonal comparison of Global PI for T against RH, before (Top) and after (Bottom) refurbishment (with Adaptable Seasonal Windows)

A closer look at the hygrothermal performance in each individual seasons (Figure 5) reveal a certain improvement after the intervention measures, in individual seasons, with Seasonal RII describing the extent of this improvement (Table 6). The winter and mild months are the recipient of maximum improvement (Figure 6). Winter month when looked through the ‘fixed’ window improved significantly from a very poor indoor hygrothermal performance of 10% to 70% on Global PI scale. This is a direct result of improved building fabric insulation, which ensured less infiltration of the cold winter air from outside before it gets heated to thermal comfort but not adequately humidified. However, to explain the cause for this improvement, T and RH were studied separately (Figure 7) and checked against the BS5454 specifications. A clear pattern can be noticed in the three seasons - the indoor RH would exist below the lower threshold of the BS5454 set-points and T would remain at the higher side, especially in mild and summer months. This further indicates over-heating of the air supplied to room. In addition to improved fabric insulation, the upgraded skylight ensured the interior space retains more heat leading to reduced requirement for heating, which then obviously eliminates any chance of over-heating.

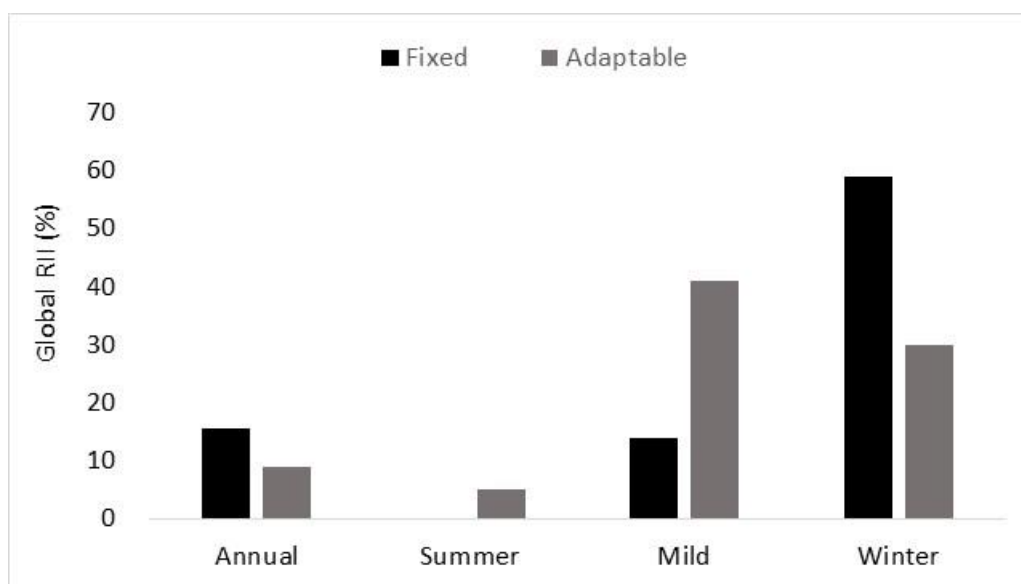
*Figure 6– Global RII comparison for improvements in two spectra – Fixed BS5454 set-points and Adaptable Seasonal Set-points strategy*

Figure 6– Global RII comparison for improvements in two spectra – Fixed BS5454 set-points and Adaptable Seasonal Set-points strategy

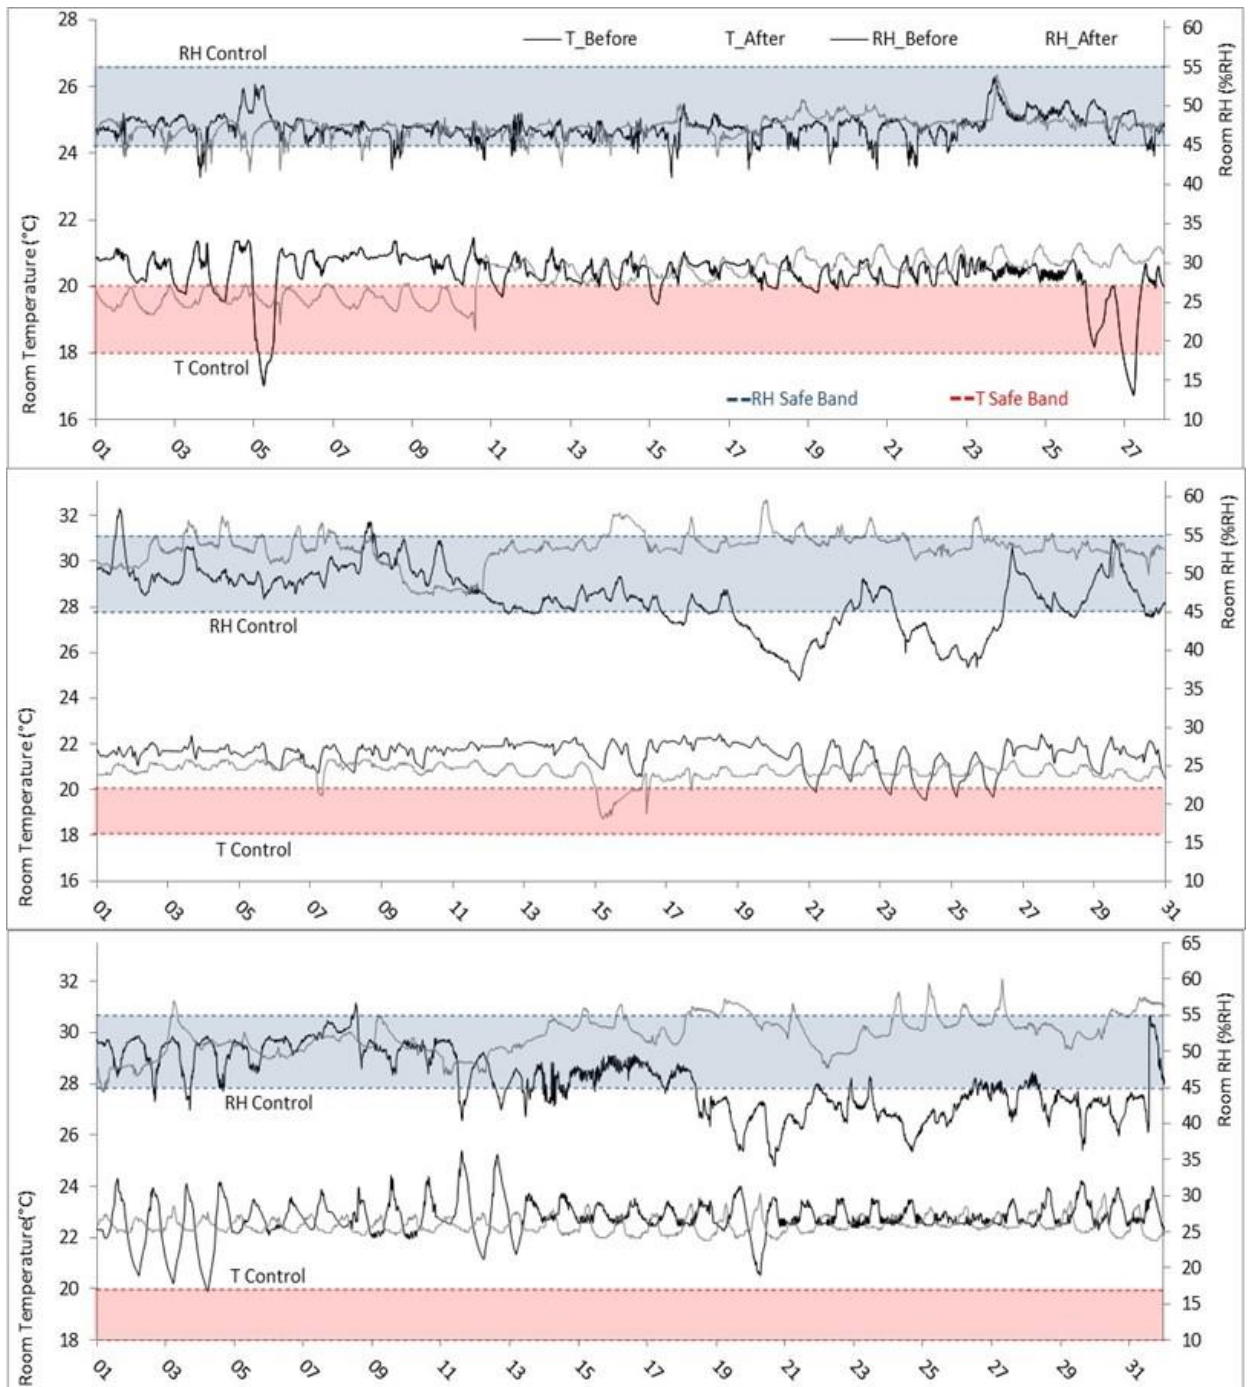
*Figure 7 - Seasonal analysis - Indoor environment in a) Cold month b) Mild month c) Hot month*

Figure 7 - Seasonal analysis - Indoor environment in a) Cold month b) Mild month c) Hot month

Figure 7 also reveals that while RH performance improves, especially during the mild and hot months, T experiences a poor performance even after refurbishment. Table 7 further highlights that the only negative RII figures in this study are obtained for indoor T during summer months indicating performance deterioration after renovation. However, this becomes less concerning if we check in the same table that the performance of T after refurbishment is 90% (PI) if looked through the seasonal set-point window. This can be further justified by the fact that main concern during the hot months is RH, which is more critical for artwork conservation than T. Hence,

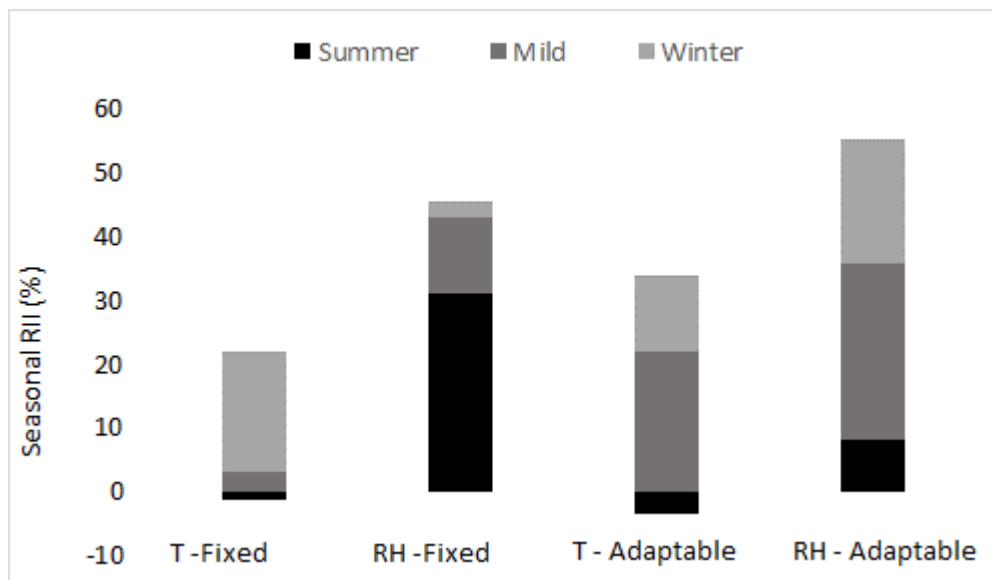
*Figure 8 – Seasonal RII for indoor T and RH over two spectra – Fixed BS5454 set-points and Adaptable Seasonal Set-points strategy*

Figure 8 – Seasonal RII for indoor T and RH over two spectra – Fixed BS5454 set-points and Adaptable Seasonal Set-points strategy

T is deliberately allowed to drift more loosely in order to maintain an adequate indoor RH. Figure 8 further supports this observation by revealing that the RH performance has improved the most if looked through both the fixed BS5454 and adaptable seasonal windows.

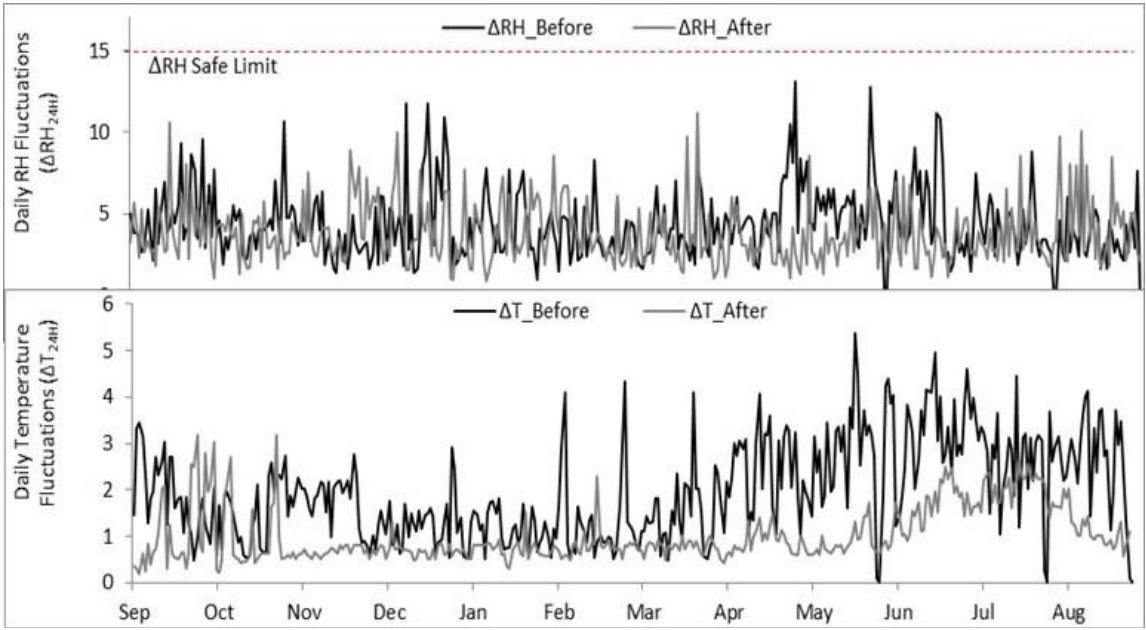
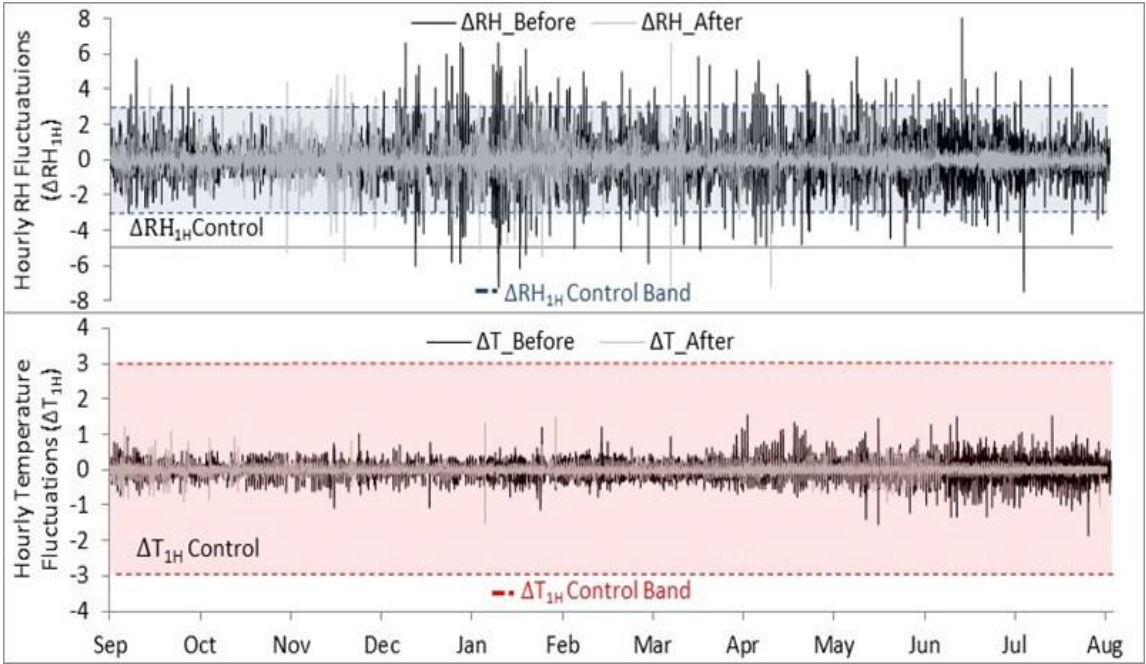
*Figure 9 - Comparison of T and RH fluctuations before and after the refurbishment for a year – a) daily fluctuations    b) hourly fluctuations*

Figure 9 -Comparison of T and RH fluctuations before and after the refurbishment for a year –  
a) daily fluctuations      b) hourly fluctuations

The NGS experiences a very good performance in terms of indoor hygrothermal stability in the cases of both daily and hourly fluctuations (Figure 9). It can be seen that only hourly RH had the scope for improvement, which it did after the refurbishment and the Fluctuation RII (Table 8) provides the extent of this improvement. While the skylight upgrade and building fabric insulation has made the building more robust to external weather changes, improved and adequate supply air flow rates further maintains the desired stability. It is also worth noting that the high thermal mass of the building fabric helps to overcome any significant outdoor weather changes causing ‘hourly’ fluctuations and this justifies the ‘daily’ fluctuations existing well below the safe thresholds.
